Manhole Inspection Summary

Manhole # S33QQ_004MH

Insp Date: **4/20/07 9:58 AM**

Location Address: **2500 MARYLAND AVE**

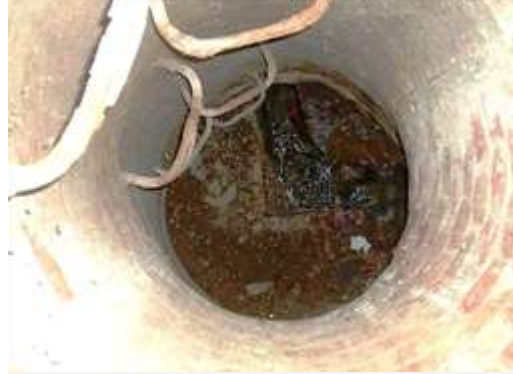
Top View

Corroded steps. Bench and Channel debris.

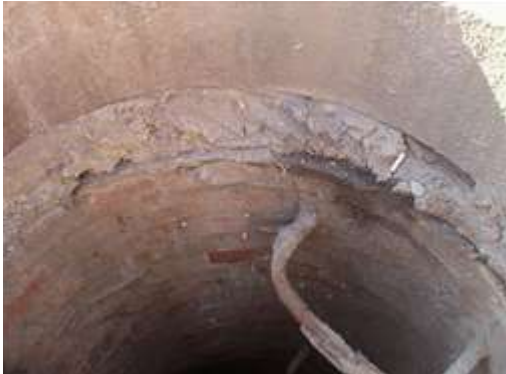
Defect

Frame leaks. Adjustment deterioration and infiltration. Corbel infiltration - other side.

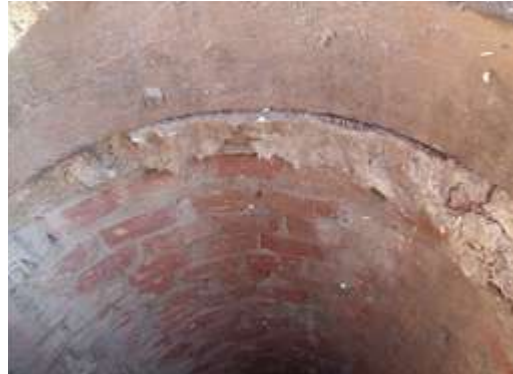
Defect

Frame leaks. Adjustment deterioration and infiltration. Corbel infiltration.

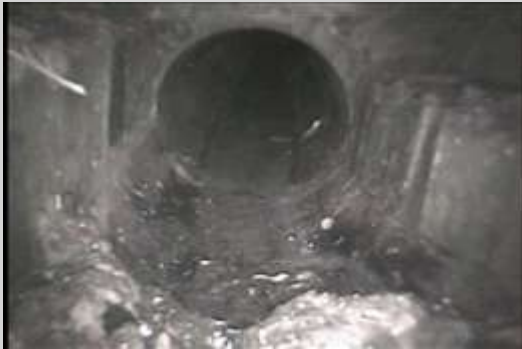
8 in. Circular Gravity Sewer Pipe Out @ 12 O'Clock

Pipe Material: **Clay** ☐ Pipe Lined

Invert Depth: **10.22** (ft.) Flow Characteristics: **Slow**

Deposits: ☒ None ☐ **Mud** ☐ Sludge ☐ **Debris** ☐ Grease

Infiltration: **None** Pipe Seal Cond: **Unknown**

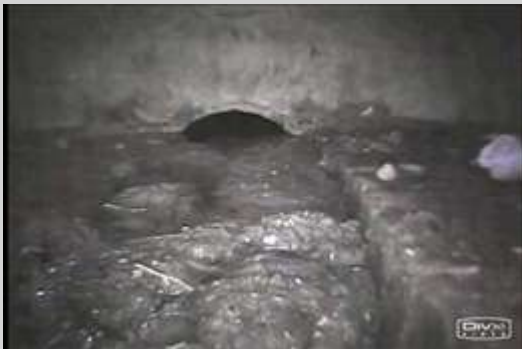
8 in. Circular Gravity Sewer Pipe In @ 3 O'Clock

Pipe Material: **Clay** ☐ Pipe Lined

Invert Depth: **10.11** (ft.) Flow Characteristics: **Slow**

Deposits: ☐ None ☒ **Mud** ☐ Sludge ☒ **Debris** ☐ Grease

Silt Depth: **5** (in.) Deposits Extent: **Heavy**

Infiltration: **None** Pipe Seal Cond: **Unknown**
